December 10, 2021

Reference: Structural Inspection of Fire Station Suspended Slab

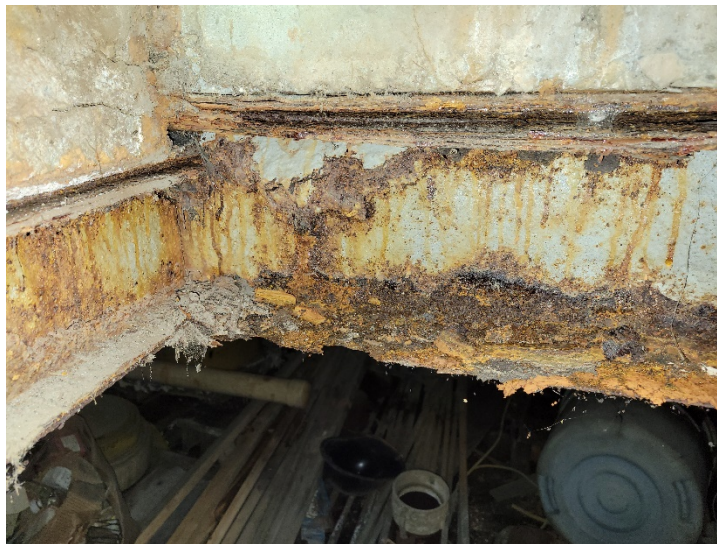
During the site visit, the floor in question was unoccupied and a full visual inspection of the floor surface and the framing beneath the floor was completed. Inspection of the steel framing showed that many of the steel beams that support the floor are severely rusted (see photographs 1 and 2). In fact, in one location the bottom flange of the steel beam was completely severed. Calculations indicated that the steel beams in their current condition can not support significant wheel loads and even in their original condition could only support wheel loads of approximately 10,000 pounds. In addition to the damage to the steel beams, the slab has been compromised. The existing slab is 6" thick and has unknown reinforcement. At some locations random reinforcement steel was discovered but the reinforcement steel was severely compromised. In examining the underside of the slab several locations of severe spalling were also discovered (see photographs 3 and 5). The spalling likely indicates that the reinforcement that is not visible currently has rusted sufficiently to expand and damage/compromise the slab.

Photograph #1 – Steel beam with missing bottom flange and severe rust.

Based upon the results of our analysis and visual inspection, we continue to recommend that the slab remain unoccupied by emergency vehicles. In order to reopen the apparatus bay to emergency vehicles, we recommend that the existing suspended slab be removed in its entirety and be replaced with a slab on grade sufficient to support the heavy wheel loads of the trucks and ambulance. It is my professional opinion that the replacement of the slab is the best long-term solution for the town. At your request, we have completed design of the repairs necessary. The attached drawings S1.0 dated December 10, 2021 should be sufficient to price, permit, and bid the project.

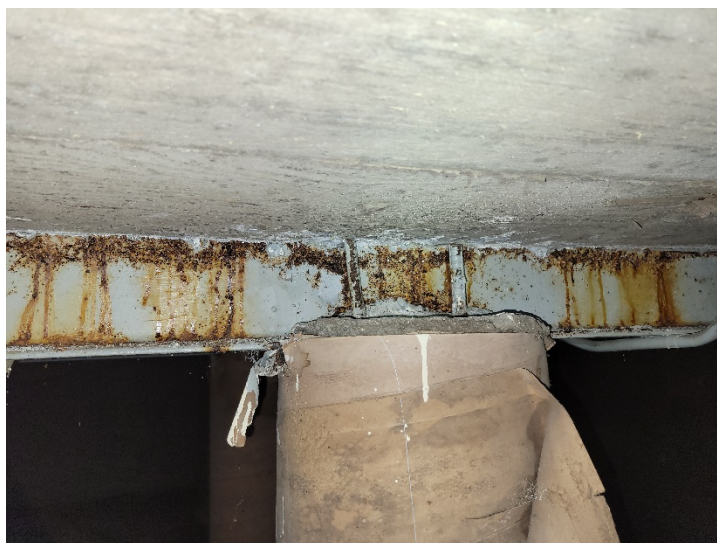
Photograph #2 – Steel beams with lower severity of rust damage.

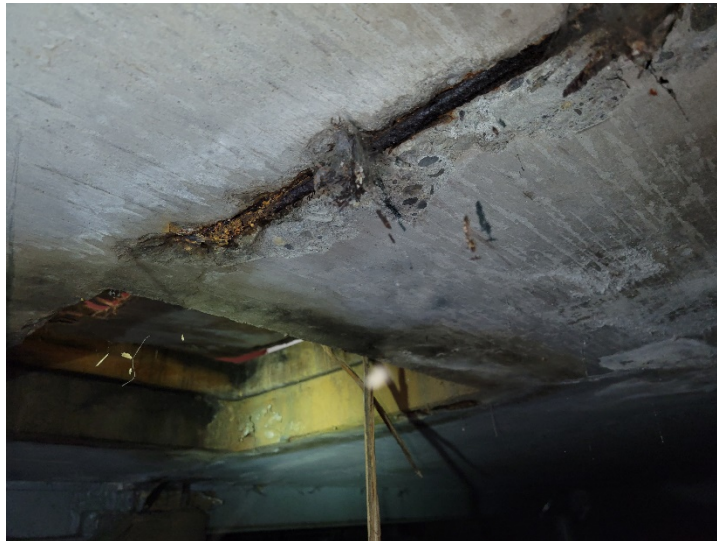
Photograph #3 – Severe rust and spalling in concrete slab reinforcement and concrete slab.

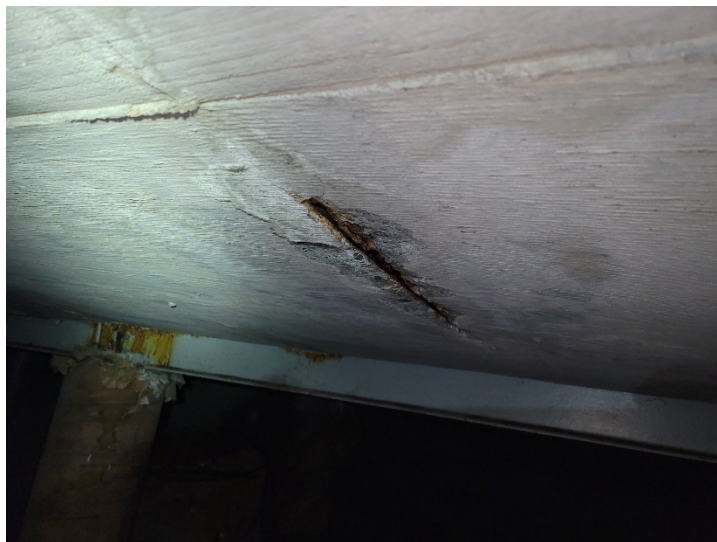
Photograph #4 – Rust and spalling in concrete slab reinforcement and concrete slab.

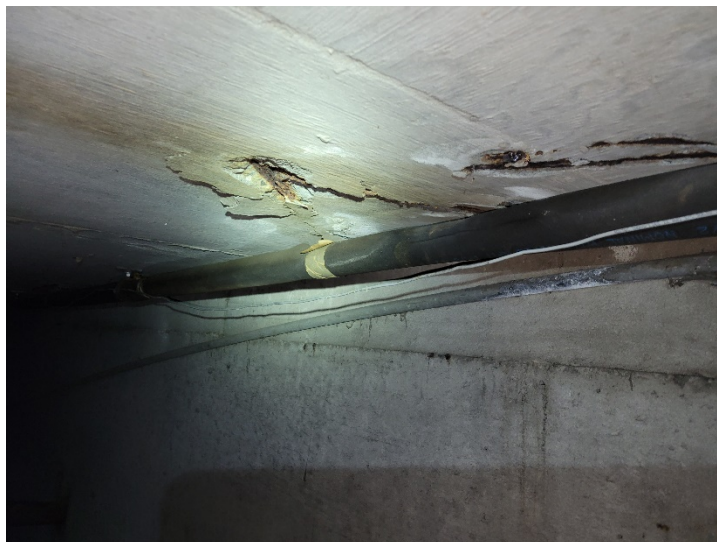
Photograph #5 – Spalling and slab damage
