December 10, 2021

Reference: Structural Inspection of Fire Station Suspended Slab

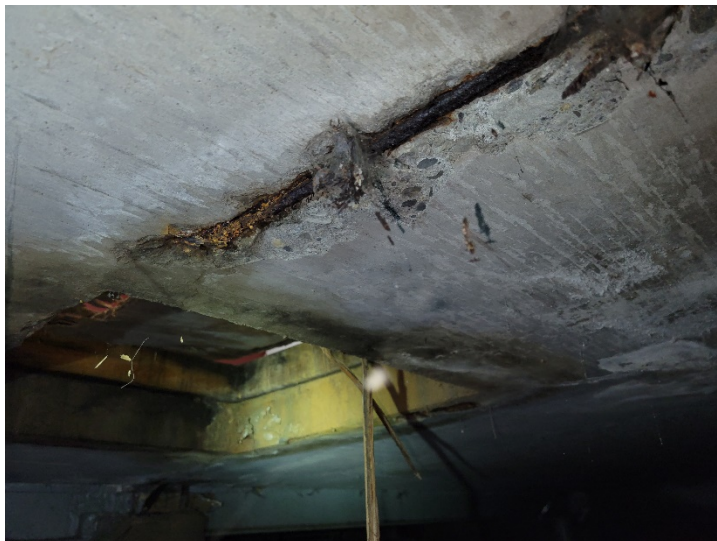
Photograph #3 – Severe rust and spalling in concrete slab reinforcement and concrete slab.

Based upon the results of our analysis and visual inspection, we continue to recommend that the slab remain unoccupied by emergency vehicles. In order to reopen the apparatus bay to emergency vehicles, we recommend that the existing suspended slab be removed in its entirety and be replaced with a slab on grade sufficient to support the heavy wheel loads of the trucks and ambulance. It is my professional opinion that the replacement of the slab is the best long-term solution for the town. At your request, we have completed design of the repairs necessary. The attached drawings S1.0 dated December 10, 2021 should be sufficient to price, permit, and bid the project.

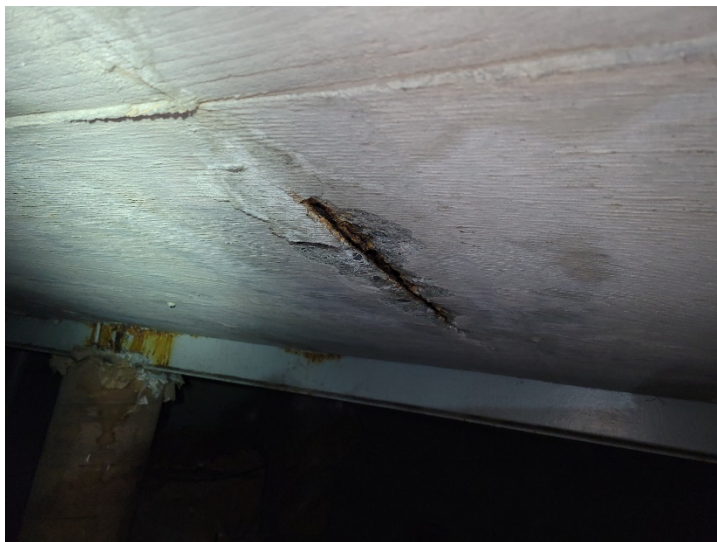
Photograph #4 – Rust and spalling in concrete slab reinforcement and concrete slab.

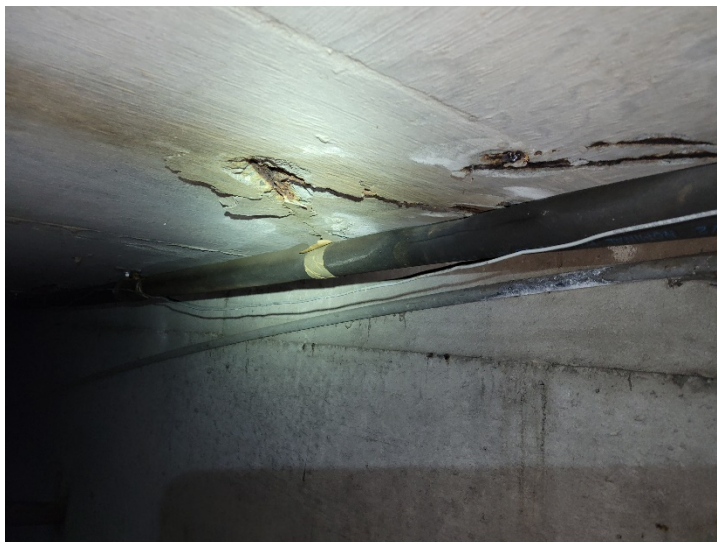
Photograph #5 – Spalling and slab damage
